# Building Durable Driveways: The Romans Did It, So Can You!

By Jeff Truman

### **Case Study: 11-storey Condominium in Midtown Toronto**

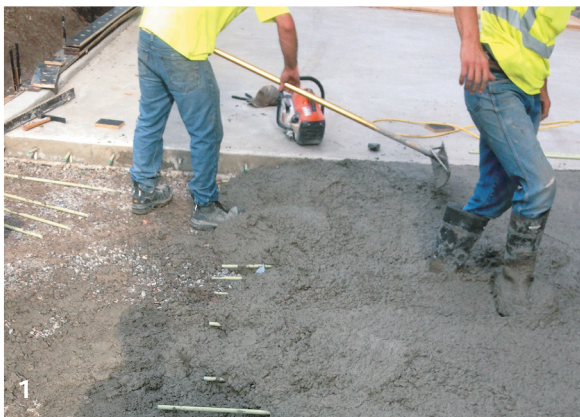
Clockwise from left: 1) Concrete with GFRP Reinforcing; 2) Adhesive installation; 3) Grouting the joints. 4) The finished driveway. Photos: Supplied.

However, as in ancient Rome, the first improvement was to dig down to expose the sinkhole and fill to solid using compacted gravel. Lean concrete was installed along the edge of the roof slab as a “plug” prior to installation of the new concrete slab. This concrete slab was poured in sections; the two ends and middle of the curved driveway were first, and the middle sections last. Glass Fibre Reinforced Polymer (GFRP) reinforcing bars were placed across the pour joints and were also used to reinforce the cantilever. Since the driveway would be subject to de-icing salts, the GFRP bars will not corrode as steel bars would. The concrete was reinforced with polymer fibres at a rate that optimized the bending strength

of the slab. The concrete was a non-shrink mix, and was continuously wet-cured with burlap for at least four days. Prior to laying the stone, there was not one crack, despite being poured in August.
